MERRIMACK RIVER BASIN
CAMPTON, NEW HAMPSHIRE

CAMPTON POND DAM
N.H. 00130

PHASE I INSPECTION REPORT
NATIONAL DAM INSPECTION PROGRAM

JUNE 1979

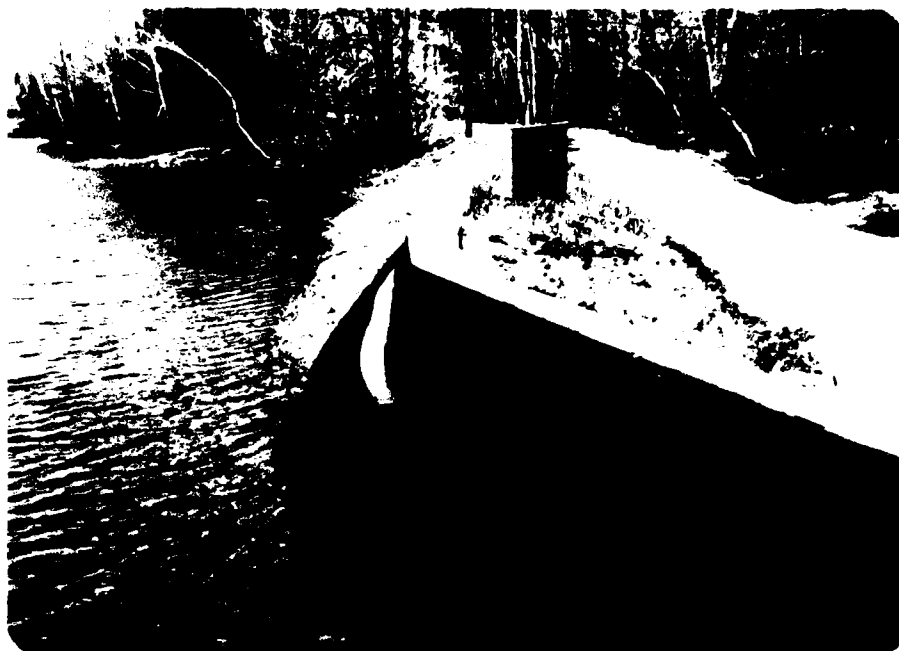
During the June 30, 1973 flood a leak developed through the left abutment wall upstream of the dam. In 1978 a concrete cut-off wall was constructed along the upstream face of the abutment wall effectively sealing the leak. The new wall can be seen in Photo 3.

The left abutment wall experienced some significant leakage during the 1973 storm. This portion of the wall is constructed of stone masonry with a concrete top. The masonry joints apparently deteriorated to a point where leakage occurred during water levels in excess of the crest elevation. The condition was corrected in 1978 with the construction of a 2-foot thick concrete facing on the upstream side of the wall (see Photo 3).

Photo 3 illustrates the earth dike. Due to seepage through the dike, the Forest Service installed a drain system on the downstream side of the dike in 1977 and constructed an 8-foot deep concrete cutoff wall on the upstream side of the masonry retaining wall in 1978. At the time of inspection, the dike showed no signs of leakage. It could not be ascertained whether there was any discharge from the downstream drain because the drain connects with a culvert that also contains the flow from a stream.

#3. VIEW OF LEFT ABUTMENT AND CORE WALL SHOWING
NEW CONCRETE FACING

1. Observe the performance of the earth dike during high water conditions.
2. Investigate the need for increased spillway capacity.
3. Establish formal written procedures for installing the highway stop logs and for evacuating downstream residents in the event of an impending dam failure.
